St Luke's Anglican Church

Conditions Assessment & Recommendations Report

1 Pelissier Street, Yea 3717 VIC

PROJECT NAME	St Luke's Anglican Church, Yea		
File name	Conditions Assessment & Recommendations Report	Project number	7678

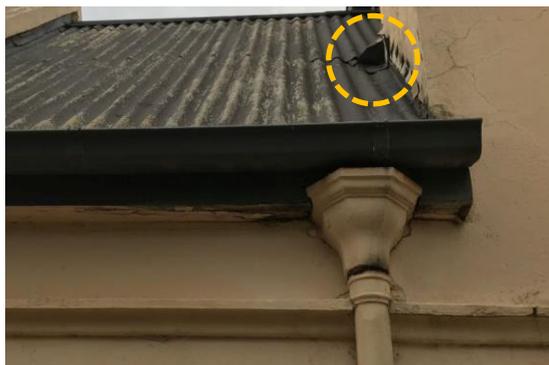
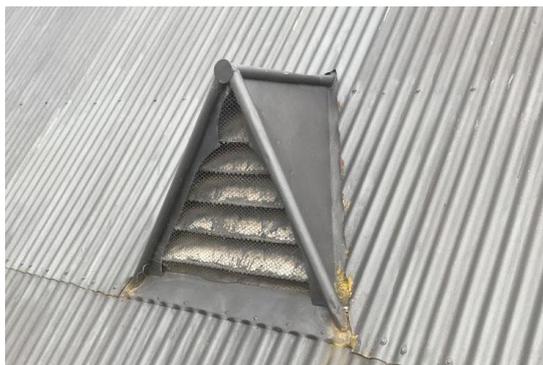
Element	Material	Condition	Recommendation	Priority
Sheet Roof	Corrugated iron (painted)	Poor	<p>The corrugated iron sheet roof has been painted a grey colour and appears to be in relatively poor condition. Corrosion is present, clearly visible in localised areas and generally apparent where paint is deteriorating. It is assumed that in the first instance, the roof may have been painted to conceal the deteriorating roof sheets.</p> <p>Flashing between the gable walls and roof appear to be insufficient or missing, with previous reparative works adding layers of flashing that appear to be ineffective.</p> <p>Ridge capping sheets are lifting and separating from one another, roof screws are likely missing and subsequently water ingress (particularly from wind driven rain) may be occurring.</p> <p>It is recommended that the entire roof be replaced with a new galvanized iron sheet roof, including associated hooded roof vents, rainwater goods, downpipes and the like.</p>	U

Hooded roof vents	Sheet metal & timber	Moderate	<p>The hooded roof vents are in moderate condition. Evidence of corrosion can be identified where flashing is either insufficient or failing. The timber louvres in the hooded roof vents have deteriorated, require preparation and painting and subsequent inspection behind the applied steel mesh may result in the identification of minor repair or replacement works.</p>	U
Rainwater goods	Various	Poor	<p>Rainwater goods exhibit considerable signs of deterioration; particularly throughout the gutters, which all appear to be rusted.</p> <p>Rainwater heads have been removed and not reinstated or replaced. Where rainwater heads remain, they exhibit signs of corrosion and paint deterioration.</p>	U

Figure 2 Left: Roof sheets exhibit paint loss and corrosion, flashing lifting. Right: Hooded roof vents exhibit corrosion, timber louvres have lost most paint and require repair.

It is recommended that the entire roof sheeting, flashing, rainwater goods and hooded roof vents be replaced as a priority given the significant level of deterioration and failed previous repairs. It is also suspected that water ingress is occurring, along with overflow onto render surfaces. This is causing dilapidation to the render at a faster and more aggressive rate than would normally be anticipated.

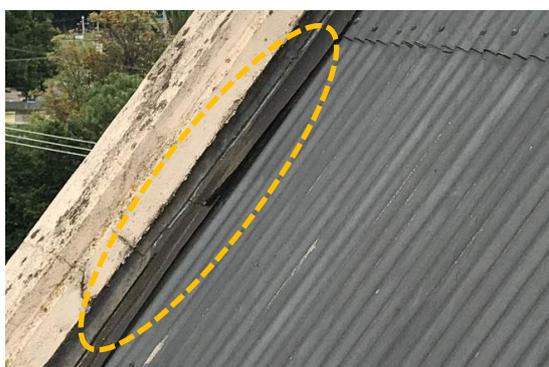
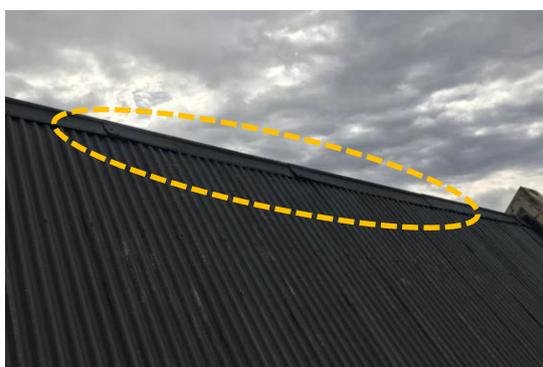
Figure 3 Left: Failing flashing, including previous repairs. Right: Ridge capping lifting, query failed fixings.

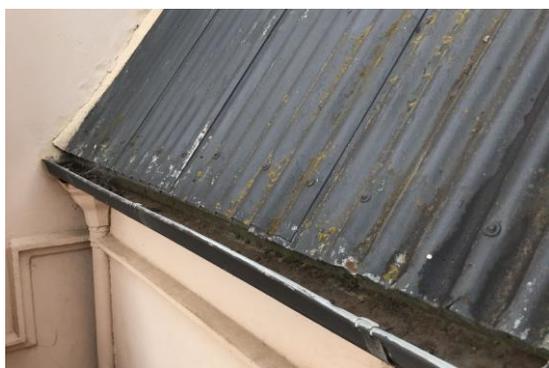
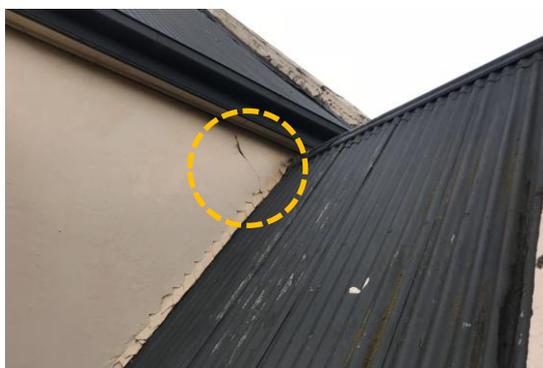
Figure 4 Left: Corroding roof sheets, corroding gutter. Right: Corroding roof sheets, crack in wall.

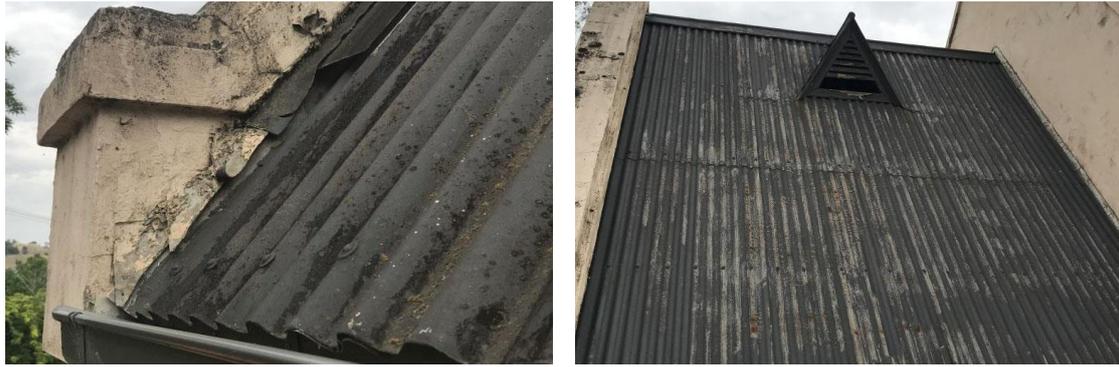
Figure 5 Left: Deteriorated flashing and roof sheeting, including previous repair on top of existing flashing. Right: Deteriorating roof sheeting.

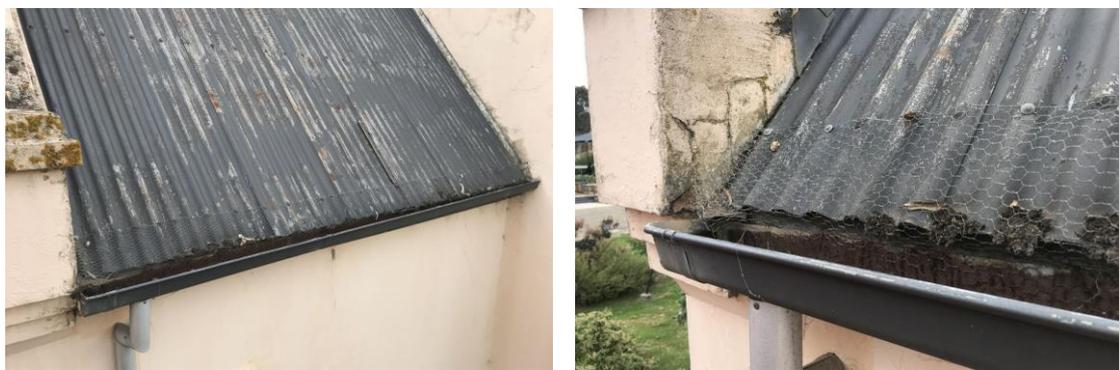
Figure 6 Left: Deteriorating roof sheeting and gutter, new galvanized downpipe. Right: Corroded gutter and deteriorated roof sheets with make-do chicken wire preventing bird access to roof cavity.

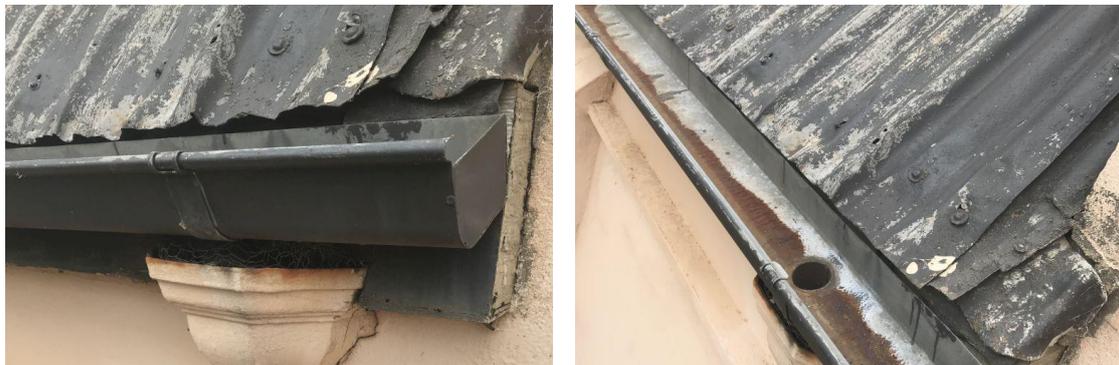
Figure 7 Left: Dilapidated roof sheeting, corrosion present in rainwater head. Right: Corroded gutter and dilapidated roof sheeting.

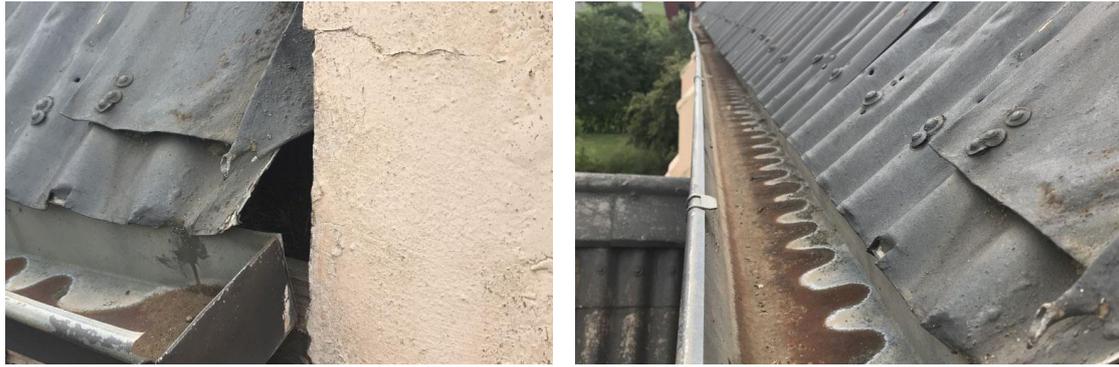
Figure 8 Left: Corroded gutter, separating roof sheeting and flashing leading to a hole in the roof. Right: Severely corroded gutter.

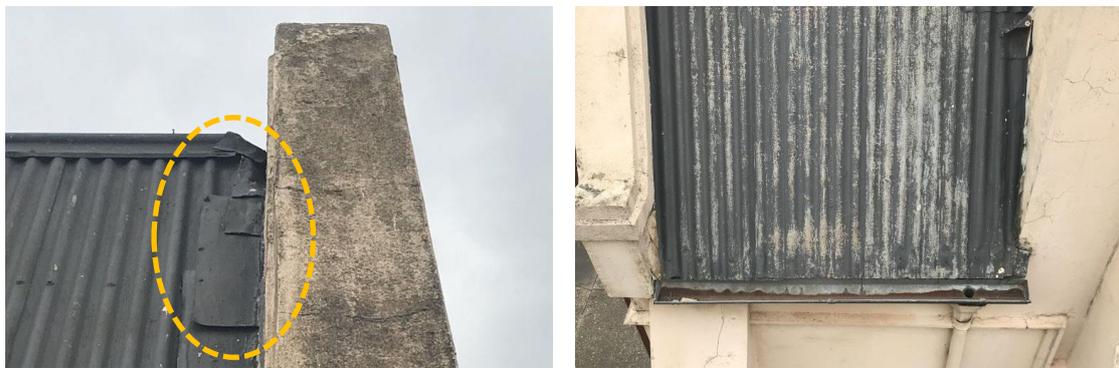
Figure 9 Left: Unsympathetic repairs to gable flashing. Right: Deteriorating roof sheeting and corroded gutter below.

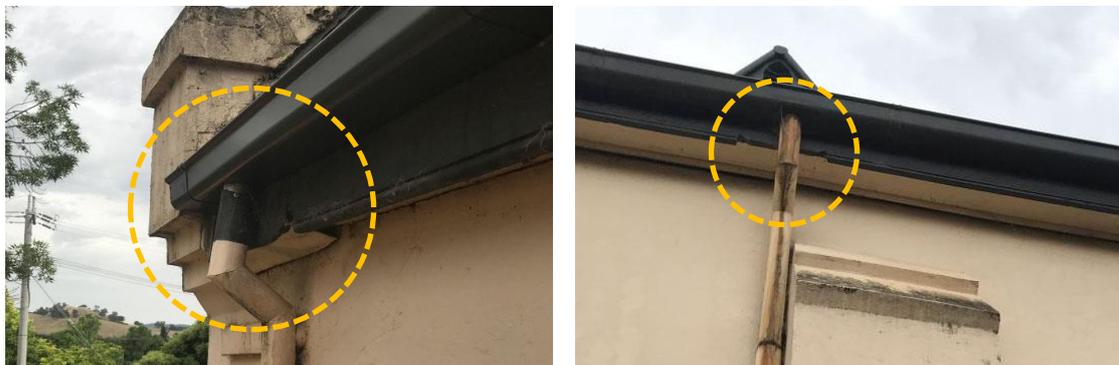
Figure 10 Left: Gutter fascia board missing, likely that rainwater head existed previously and has been replaced solely with downpipe. Right: Rainwater head missing evidenced by the

checked out gutter fascia board. Downpipe only in lieu of rainwater head, downpipe is corroded.

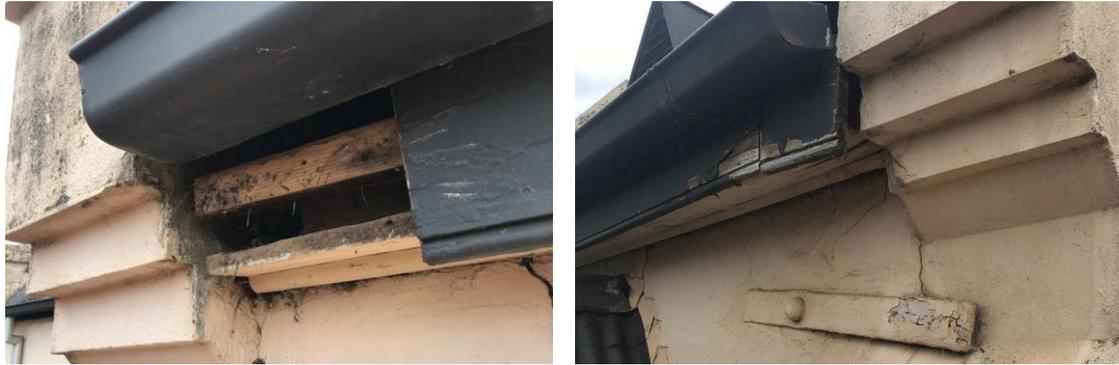
A small section, presumably a previous repair, of gutter fascia board on the Eastern side of the Church was removed to visually inspect the roof cavity. The visual inspection that resulted was limited and the small section of gutter fascia board was subsequently reinstated. No further inspection of concealed spaces was carried out. No destructive or invasive testing was carried out.

Figure 11 Left: Gutter fascia board area removed for inspection, subsequently reinstated. Right: Previous repair to gutter fascia board failing. Tie rod through wall with brace support.

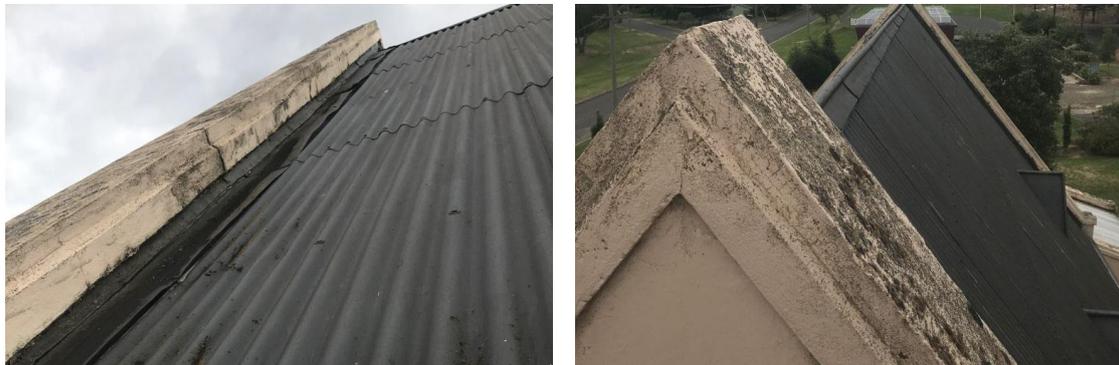
Figure 12 Left: Gable wall coping and stringcourse exhibiting cracking. Right: Organic growth on coping requiring treatment and removal.

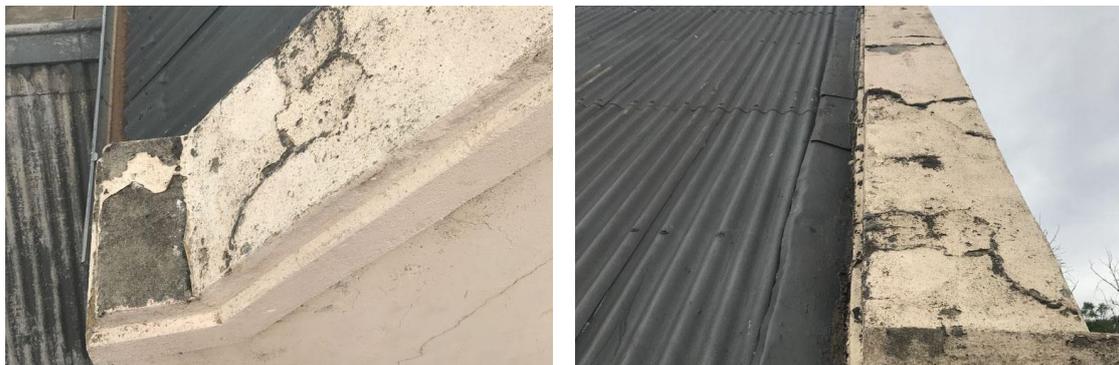
Figure 13 Left: Paint and render loss on gable wall coping and minor cracking. Right: More significant cracking through gable wall coping, with organic growth indicating cracks have existed for some time- potentially allowing water ingress.

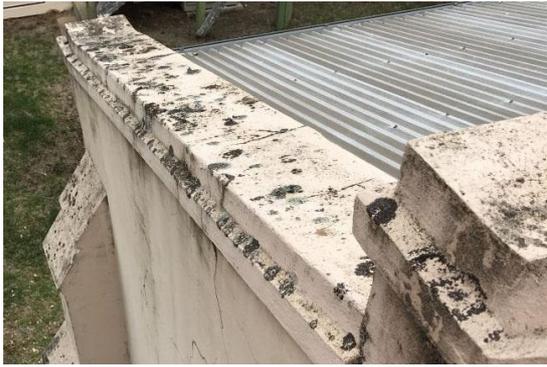
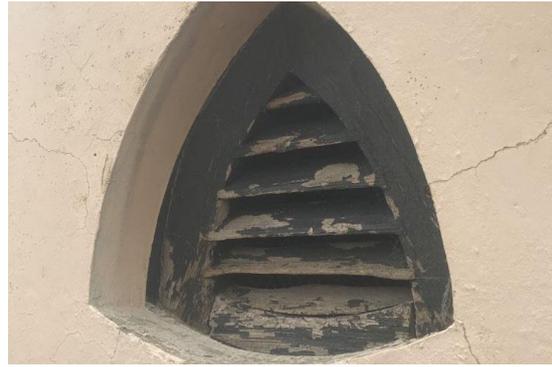
Lozenge vent	Timber	Moderate	<p>The timber louvres in the vent on the North gable requires preparation and painting. Localised warping and deterioration of timber members may require repair or replacement.</p>	
Hoodmold	Moulded render	Poor	<p>The hoodmolds above the lancet windows are largely in poor condition, whereby the peaks of the arched mouldings are frequently cracked, with the moulded render separating from its substrate. Portions of the hoodmold could easily be dislodged by hand, and therefore pose a risk to the safety of persons or property.</p>	U
Lancet windows		Moderate	<p>The lancet window openings including chamfered reveal and sill appear to be in moderate condition. Cracking is apparent through the window arch, commonly associated with cracking in the hoodmold.</p> <p><i>Refer Summary of Internal Works for stained glass windows</i></p>	A

Figure 14 Left: Organic growth and cracking to coping. Right: Gable wall vent on North side requiring preparation and painting along with minor timber repairs.

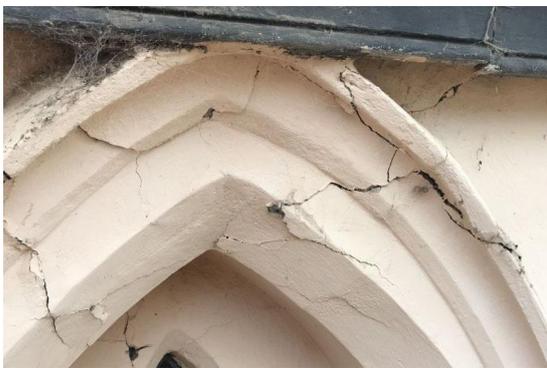
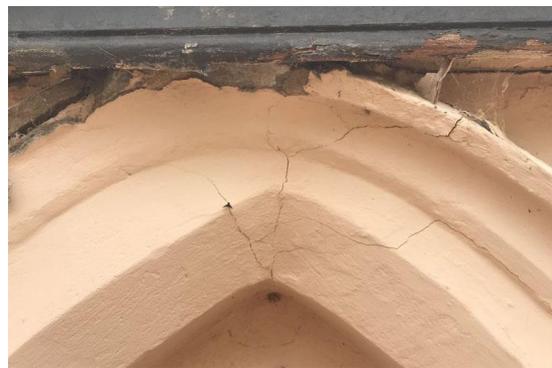
Figure 15 Left: Significant cracking through hoodmold where clashing with gutter fascia board. Right: Significant cracking through hoodmold where clashing with gutter fascia board.

Upon replacement of the roof sheeting, flashing, rainwater goods and hooded roof vents, it should be ensured that the height of the gutter and associated fascia board does not clash with the hoodmolds of the windows.

The significant cracking and detachment from substrate of the hoodmolds requires that they be rerun almost in their entirety. Given the amount some parts of render have detached and remain precariously in place, it is recommended this work be undertaken as a priority or loose material be removed.

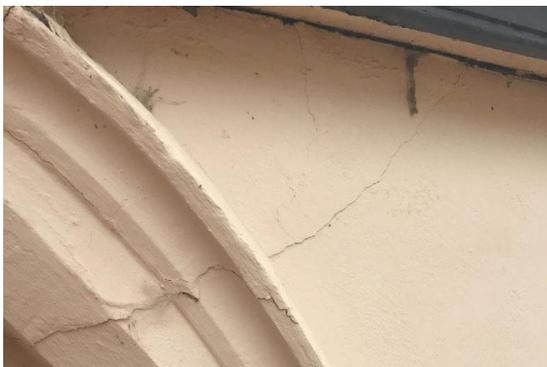
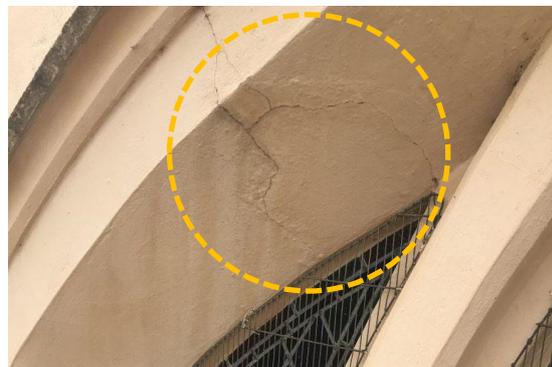
Figure 16 Left: Significant cracking through hoodmold where clashing with gutter fascia board, cracking continues through wall. Right: Significant cracking through hoodmold where clashing with gutter fascia board, cracking continues through window arch.

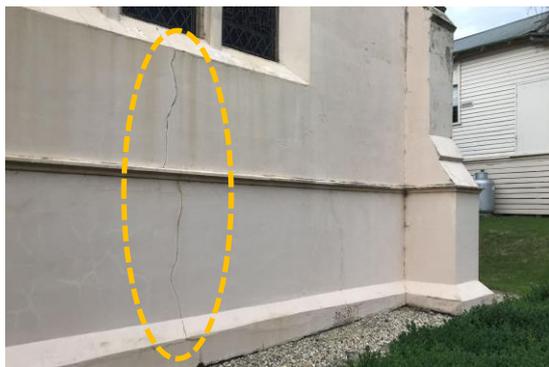
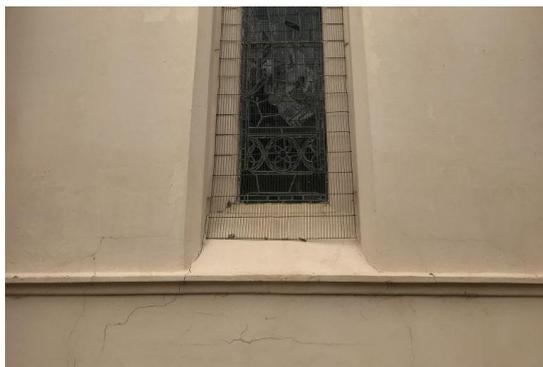
Figure 17 Left: Cracking from window sill down through stringcourse and into wall base. Right: General minor cracking in wall around window and stringcourse.

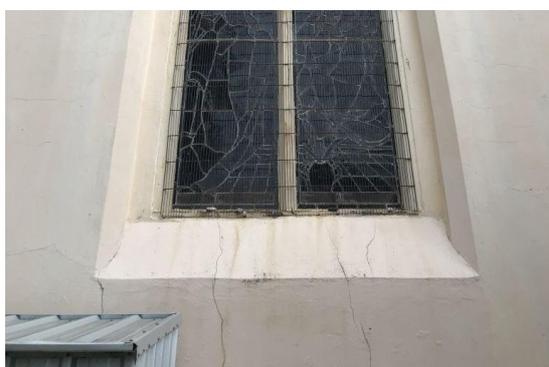
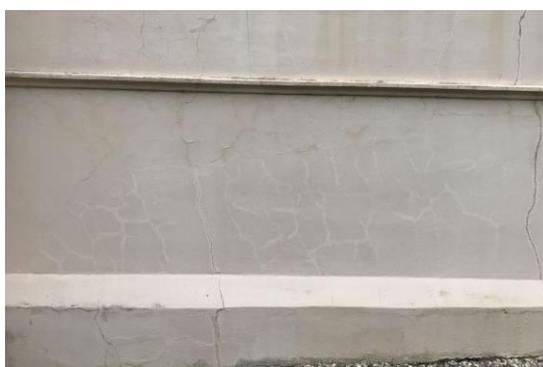
Figure 18 Left: Cracking from window sill down through wall. Right: General crazing and cracking through wall and wall base.

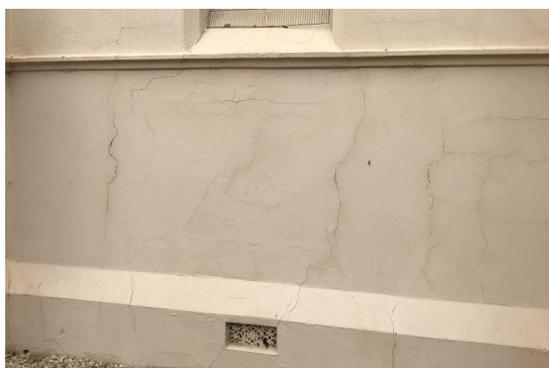
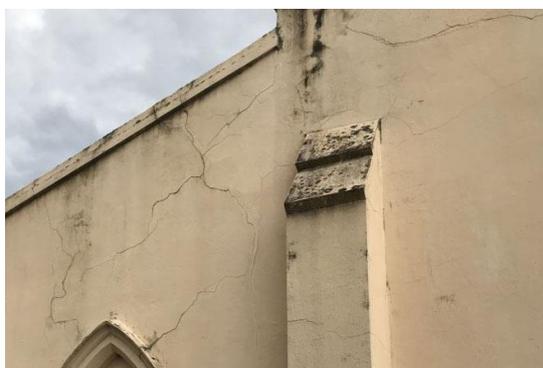
Figure 19 Left: General cracking in render. Right: More significant cracking in render, surrounding render likely to be drummy and separating from substrate.

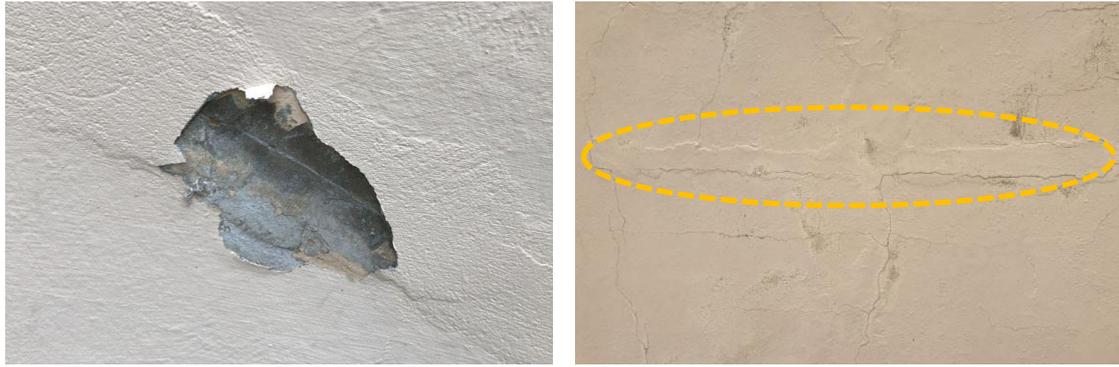
A small section of render, assumed to be a previous repair, was dislodged on the Western side of the Church. The previous repair attempted to remediate cracks running from the window opening in the wall, to the stone footing. The cracking was present beneath the repair, suggesting the root cause of the problem was not resolved.

Figure 20 Left: Area of previous render patch repair removed to expose cracking present. Right: Previous repair, assumed to be some sort of rod fixing.

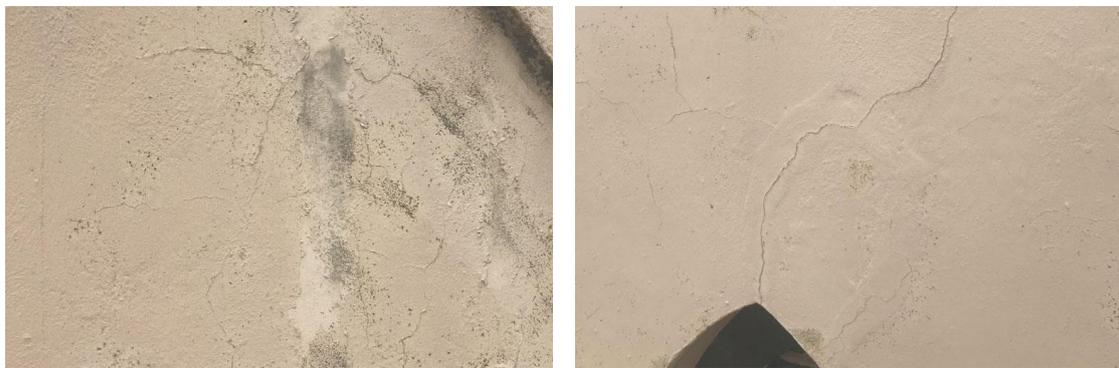
Figure 21 Left: Small amounts of efflorescence/water damage present in deteriorating render surface of North gable wall. Right: Crack from gable wall vent through wall, previous patch repair present.

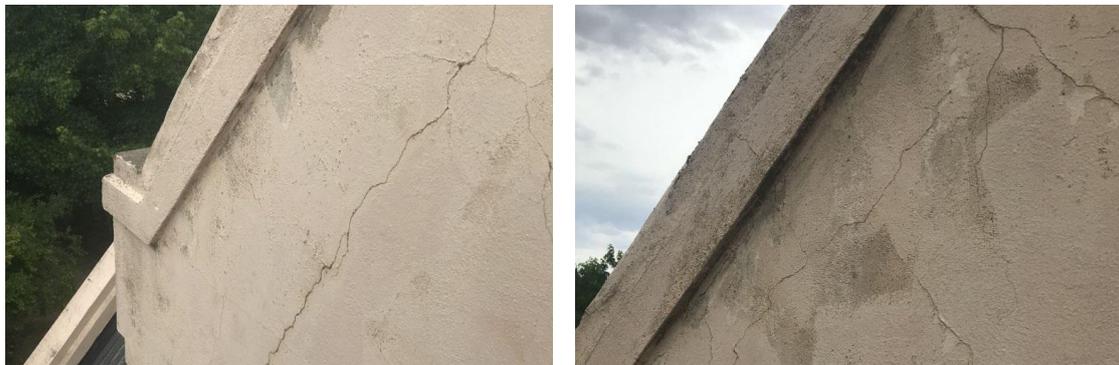
Figure 22 Left: Significant crack present through gable wall. Right: Cracking in gable wall and stringcourse.

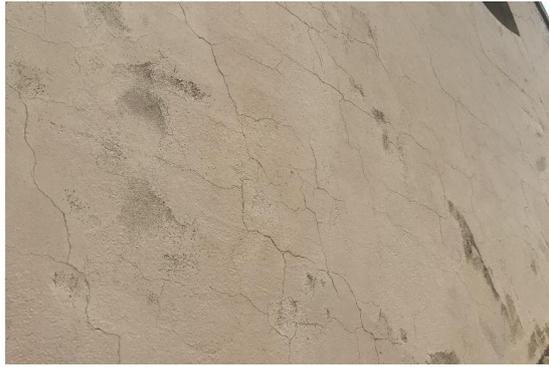
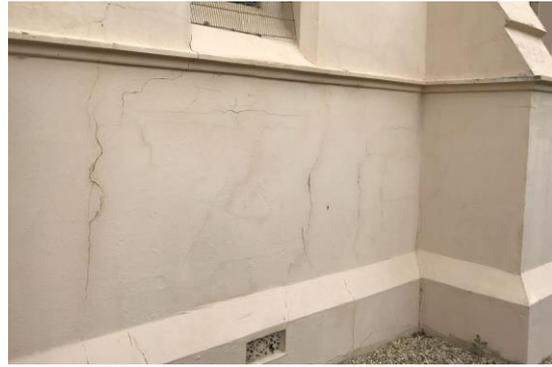
Figure 23 Left: General cracking and crazing on gable wall Right: Cracking in wall below stringcourse.

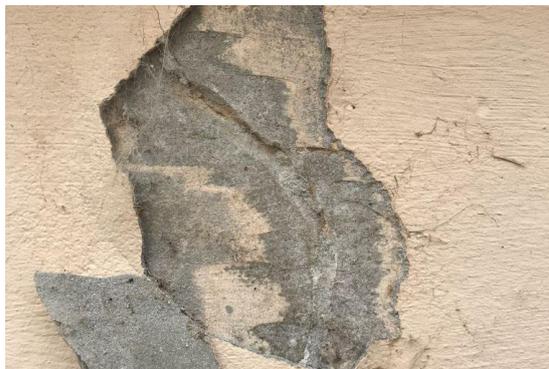
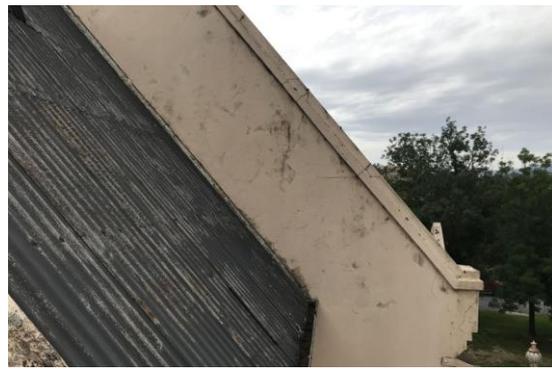
Figure 24 Left: Render separated from substrate with crack present below. Right: Cracking in gable wall.

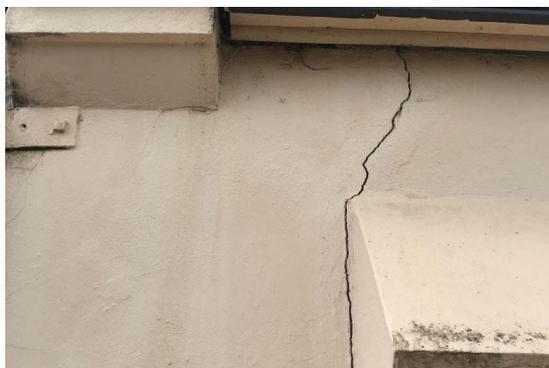
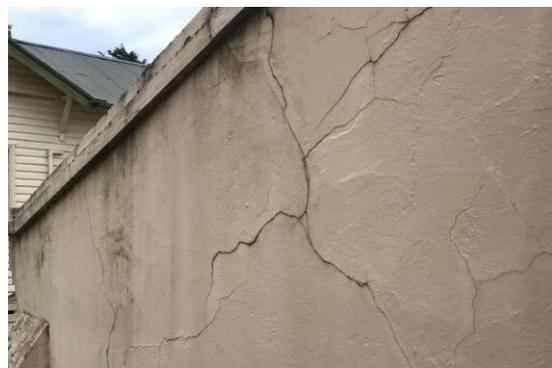
Figure 25 Left: Cracking in wall adjacent to buttress Right: Cracking in wall and drummy render.

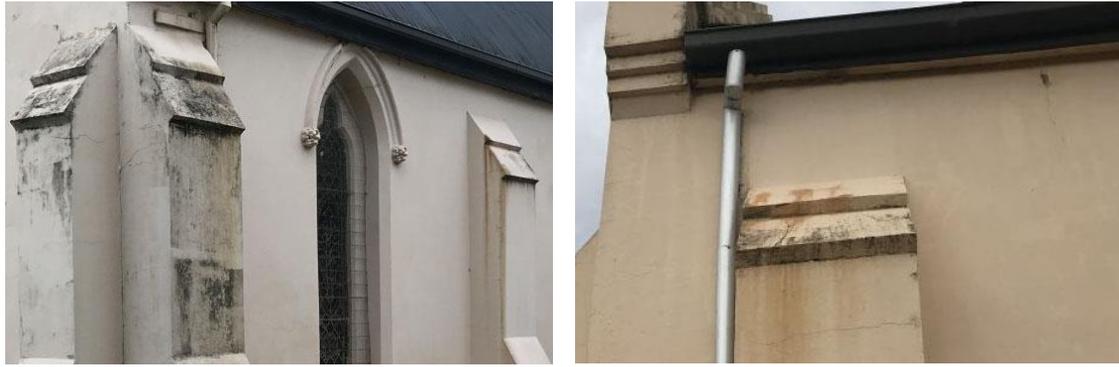
Buttresses	Flat and moulded render	Moderate	The buttresses are in moderate condition, requiring the removal of organic growth, patch repairs to areas of cracked or drummy render, re-running of moulded sections damaged or missing and a general preparation and paint.	
Stringcourse	Moulded render	Good	The stringcourse is largely in good condition, re-running of moulded sections damaged or missing may be considered. Requires preparation and paint.	C
Wall base (including stone footing)	Rendered brick and stone	Good	<p>The rendered wall base, including chamfer and stone footing appears to be in sound condition. Localised cracking associated with significant cracking in the walls should be investigated and remediated. General preparation and paint required.</p> <p>Cast iron wall vents show some sign of corrosion on the West side where by the nature of the sloping site they are closer to the ground and at times covered. Ideally, the wall vents should not be covered by earth, as this is likely to cause moisture issues such as rising damp in the walls.</p>	C

Figure 26 Left: Organic growth and cracking to buttress. Right: Dilapidated buttress and new downpipe.

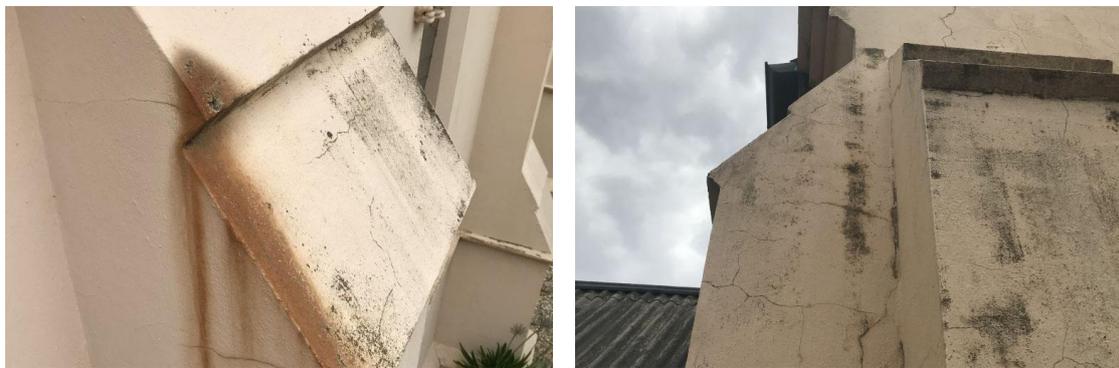
Figure 27 Left: Staining on render surface from corroded embedded metal items. Right: Cracking in render of buttress.

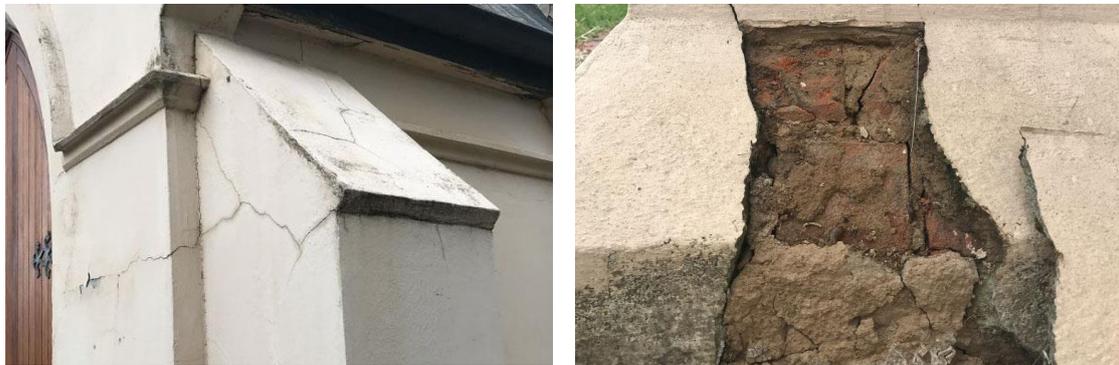
Figure 28 Left: Significant cracking in render of buttress. Right: Area of render missing from chamfered edge of wall base above footing.

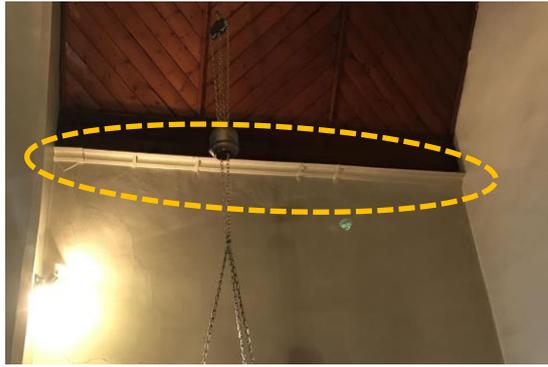
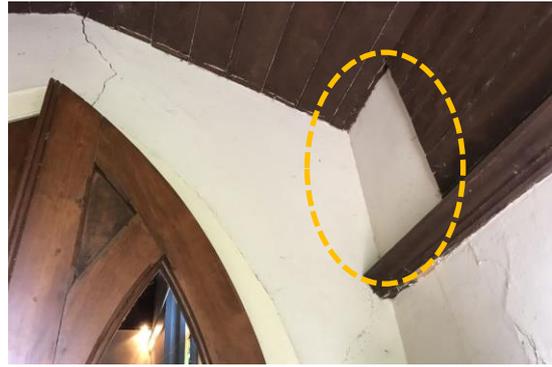
Figure 29 Left: Cornice has been removed on the opposing wall, reinstate in due course. Right: Missing portion of timber lining boards in porch entry ceiling.

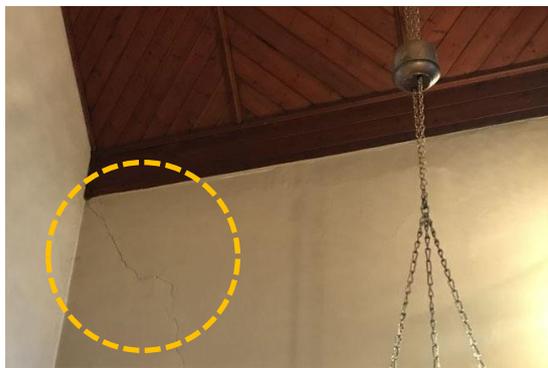
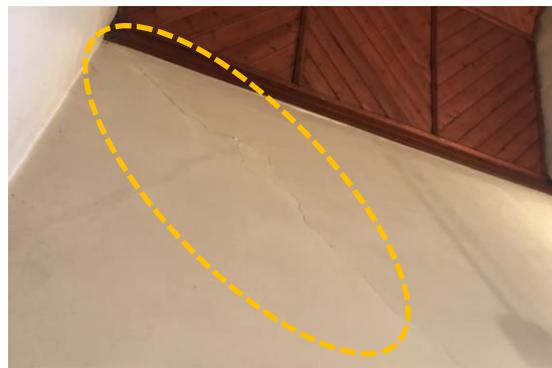
Figure 30 Left: Cracking in top corner of wall. Right: Significant cracking running diagonally across wall.

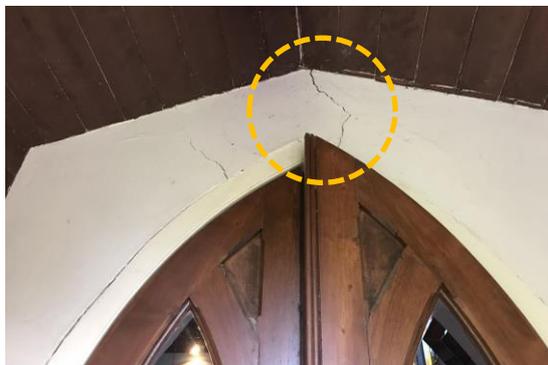
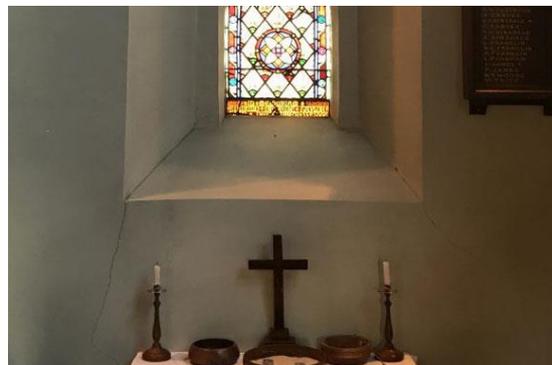
Figure 31 Left: Cracking from arch head through to ceiling Right: Cracking from window sill down wall.

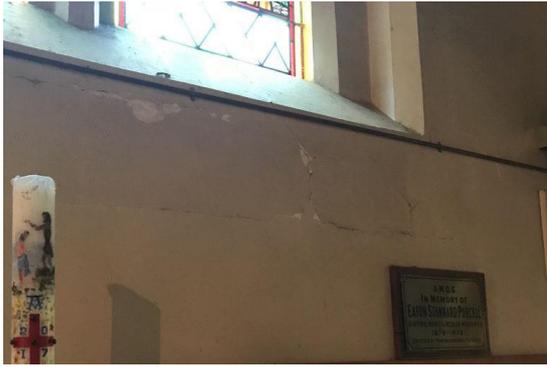
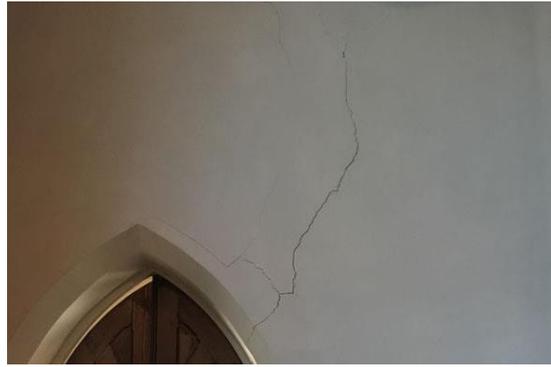
Figure 32 Left: Render damage beneath window sill appears to be caused by significant cracking, drumminess and the presence of moisture, likely through the cracks. Right: Cracking from door archway up through wall.

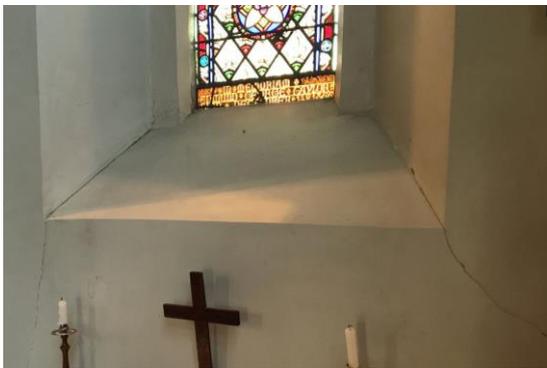
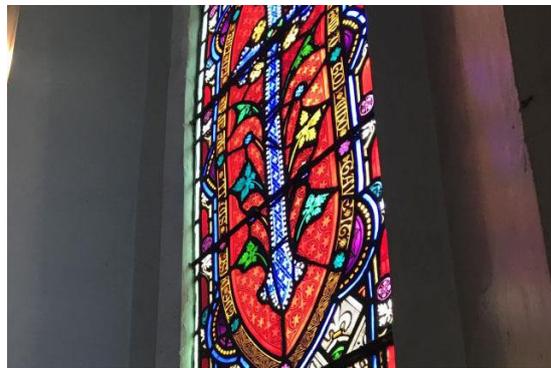
Figure 33 Left: Cracking through wall from window sill on both sides of stained glass window. Right: Bowing/buckling apparent in stained glass window, appears to be separating from frame and from window reveal.

The tensioned tie rod connecting the East and West walls near the junction of each respective wall and the Northern gable wall, appears to be restricting monolithic movement of the building, creating uneven movement and subsequent cracking. Removal of the tensioned tie rod should be considered. The movement in the wall is affecting the stained glass windows, in particular the Ferguson & Urie which is exhibiting signs of bowing and popping from its frame.

It is understood that works have recently been undertaken by Honeysuckle Stained Glass to repair the Ferguson & Urie (1868) stained glass window, and that reparative render works associated with this window are a matter of priority given an amount of funding specifically associated with the repair of the Ferguson & Urie (1868) stained glass window.

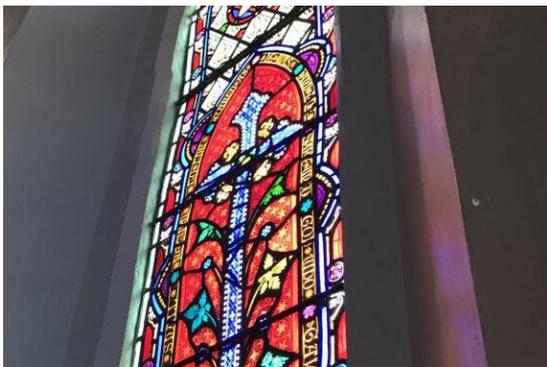
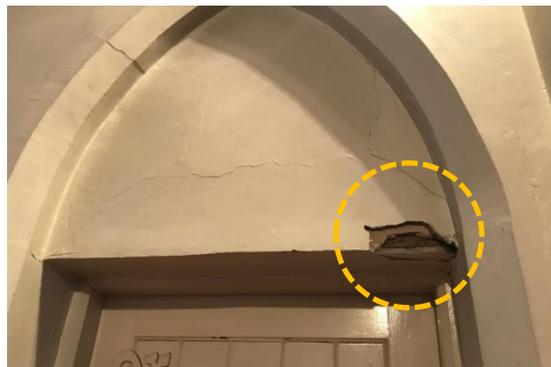
Figure 34 Left: Buckling of stained glass apparent, visible bowing and separation of the stained glass from frame and window opening. Right: Missing render above doorway and crack back through arch and wall.

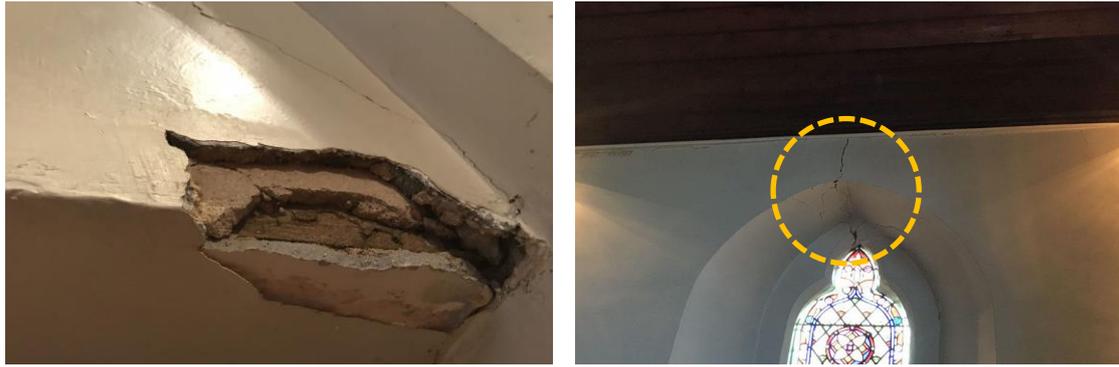
Figure 35 Left: Closer view of missing render, multiple layers of render appear to have been applied. Right: Crack through arch head of window.

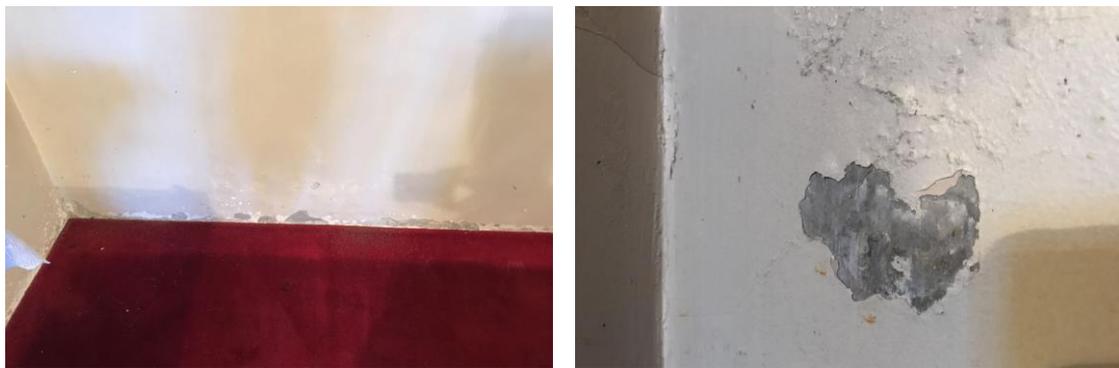
Figure 36 Left: Efflorescence present, appears to be rising damp. Right: Efflorescence and paint loss to wall.

Localised instances of rising and/or falling damp and salt attack were observed internally, often corresponding with those noted on the exterior. This condition is likely to be associated with one of a number of causes, but most likely defective rain water goods or stormwater system, resulting in ground saturation and water ingress into the structure. In some cases, the water ingress was observed in the vicinity of significant cracking in the external render.

The roof and rainwater goods should be further investigated and cleaned; and returned to good working order and where necessary, replaced. Significant cracking in the render that may contribute to water ingress should be repaired and the salt attack monitored. In the event that the aforementioned defects do not resolve the salt problem, the cause of the salt attack would need further exploration to determine the cause.

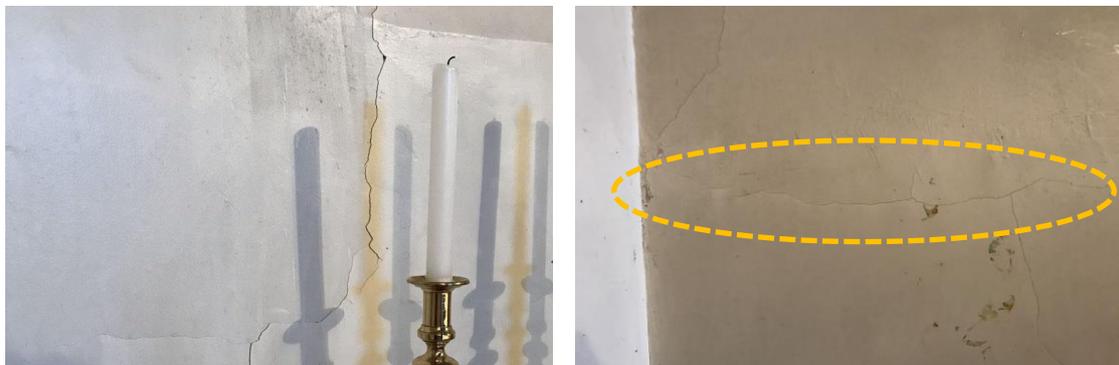
Figure 37 Left: Cracking in wall. Right: Numerous cracks running from main horizontal crack.

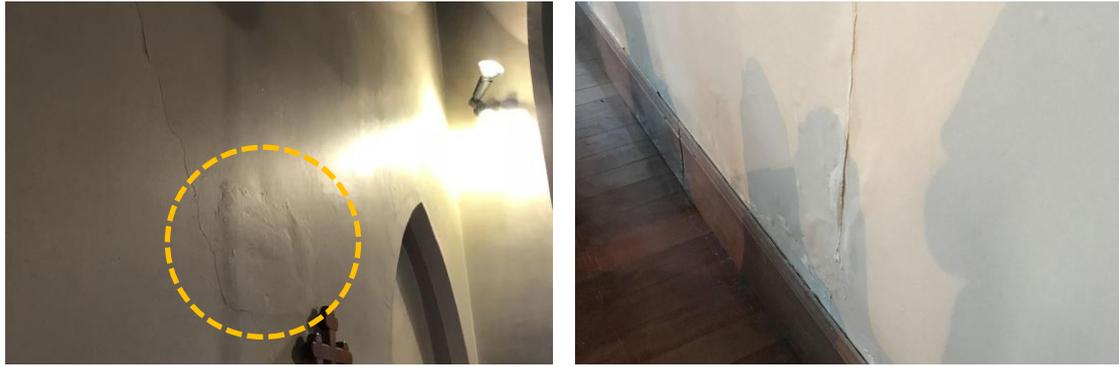
Figure 38 Left: Previous unsympathetic render patch repair, crack running diagonally adjacent to repair. Right: Rising damp along Eastern side of the building, corresponds with water ingress through crack.

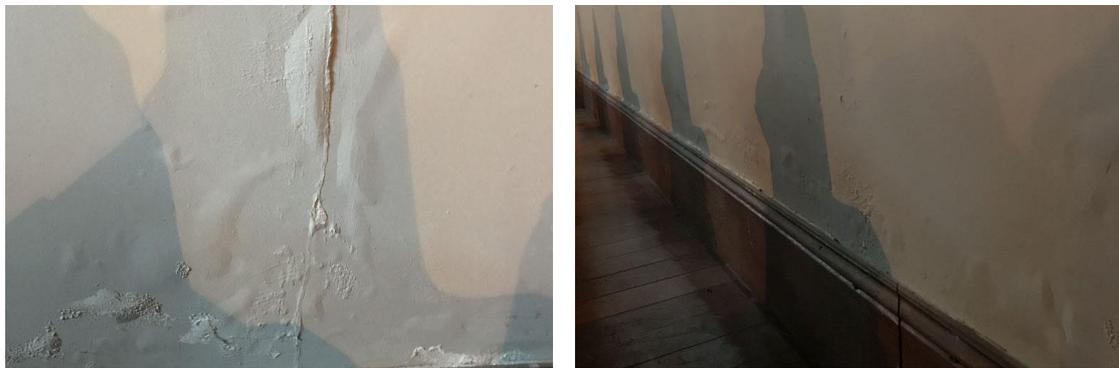
Figure 39 Left: Rising damp along Eastern side of the building, corresponds with water ingress through crack. Right: Rising damp along Eastern side of the building, corresponds with water ingress through crack.

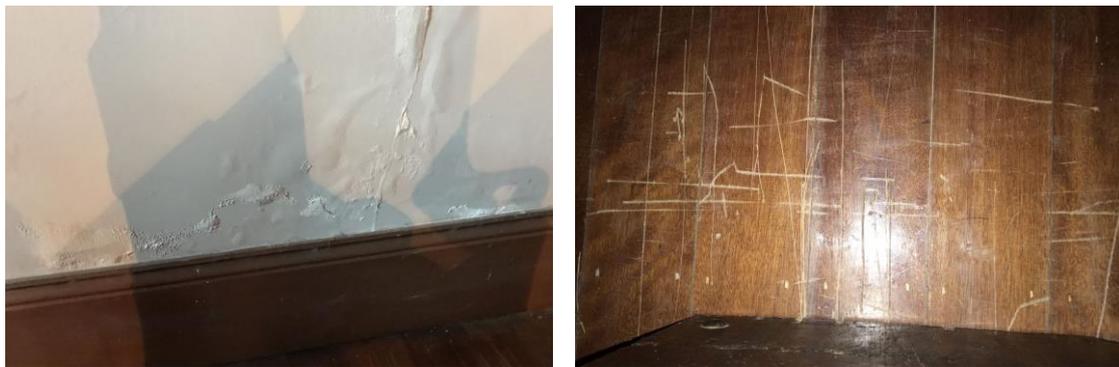
Figure 40 Left: Rising damp along Eastern side of the building, corresponds with water ingress through crack. Right: Scratch damage to timber floorboards.

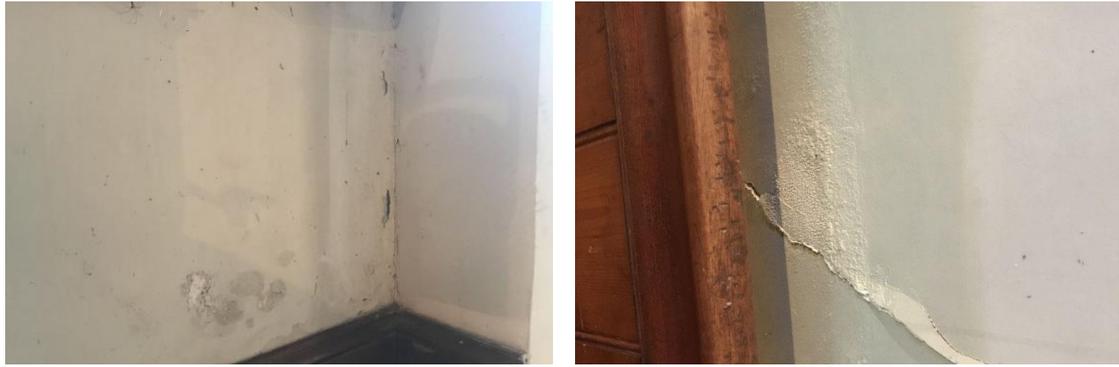
Figure 41 Left: Water damage present in entry porch walls. Right: Water damage present in entry porch walls, cracking evident.

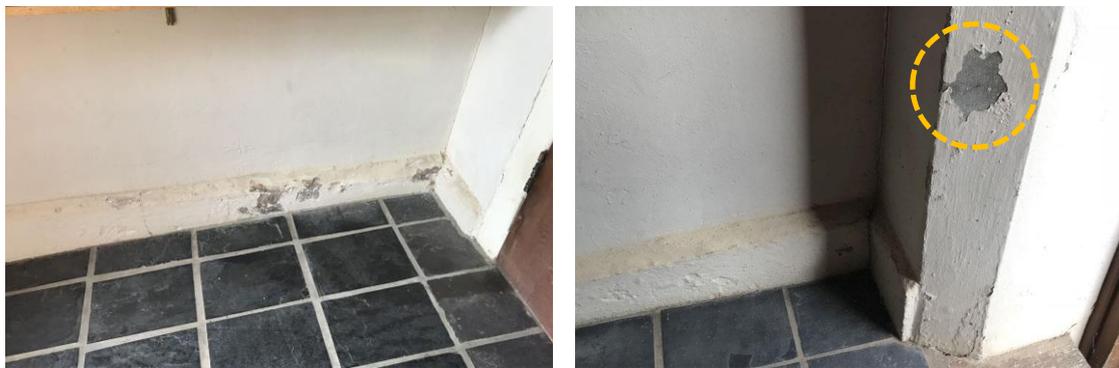
Figure 42 Left: Water damage present in entry porch moulded render skirting. Right: Paint loss to rendered stop chamfer of door.
